MISCELLANEOUS PAPER S-69-27

# LANDING MAT OVERLAY ON DETERIORATED PAVEMENT

## BARE BASE SUPPORT

U. S. Army Engineer Waterways Experiment Station  
CORPS OF ENGINEERS  
Vicksburg, Mississippi

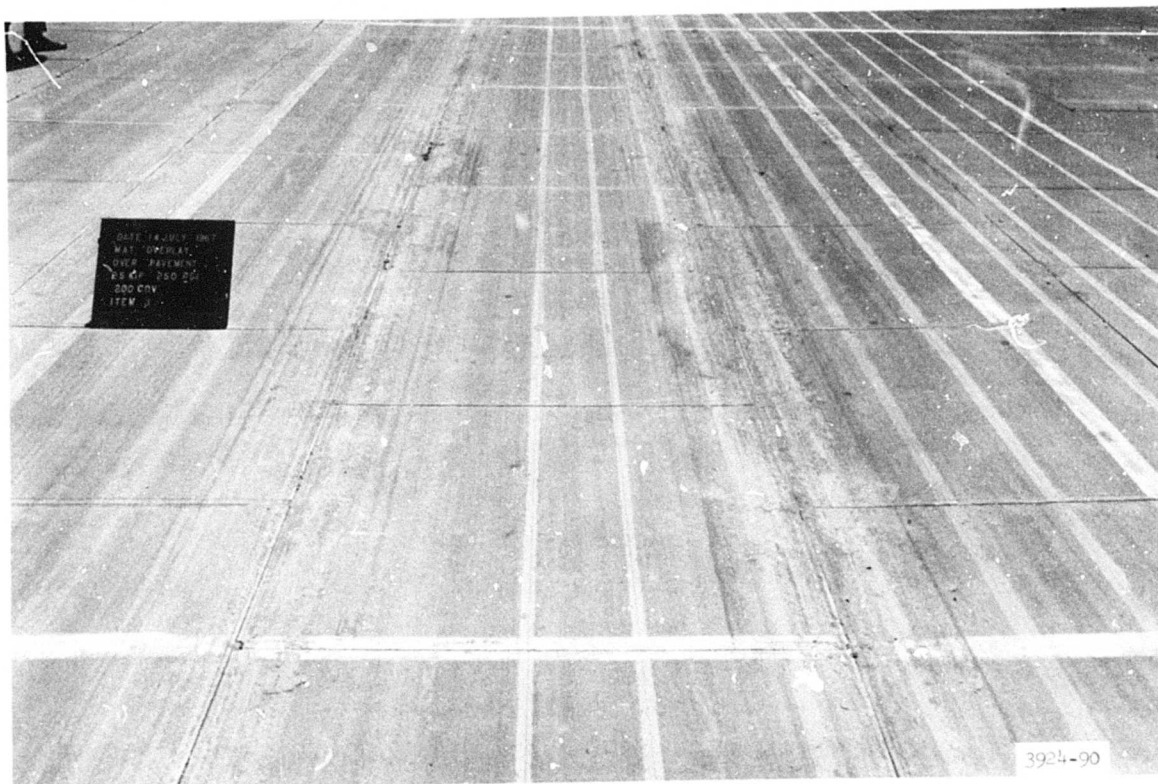
32. On 12 July, 64 coverages of traffic were applied to the test section for a total of 80 coverages. During these 64 coverages, there was a light rainfall in the test area, and it was observed that a slight amount of soil (i.e. the fines in the clay gravel) was pumping up through the mat joints in item 3. The pumping was minor, however, and did not affect the serviceability of the item. The remainder of the test section indicated no signs of soil pumping and was quite serviceable at this time.

Photograph 19. Item 3 after 120 coverages applied during light rainfall (200 coverages total). Note soil pumped onto mat surface

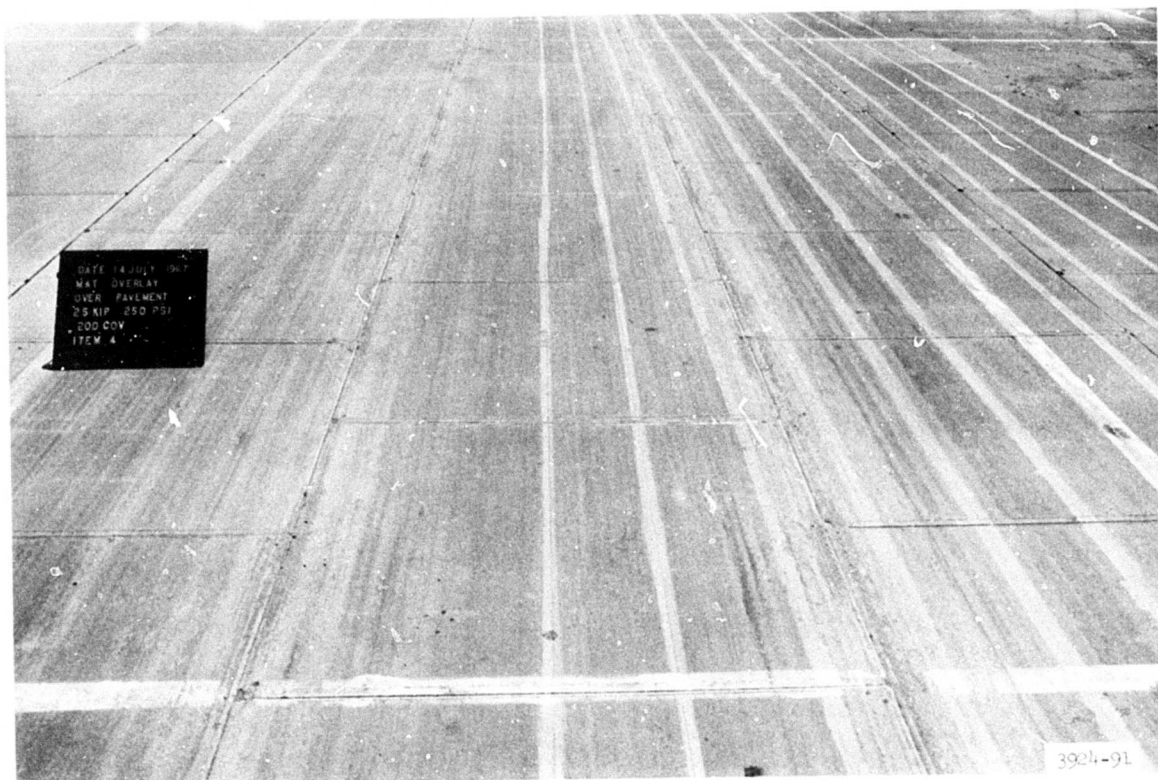
Photograph 20. Item 4 after 120 coverages applied during light rainfall (200 coverages total). Note soil pumped onto mat surface

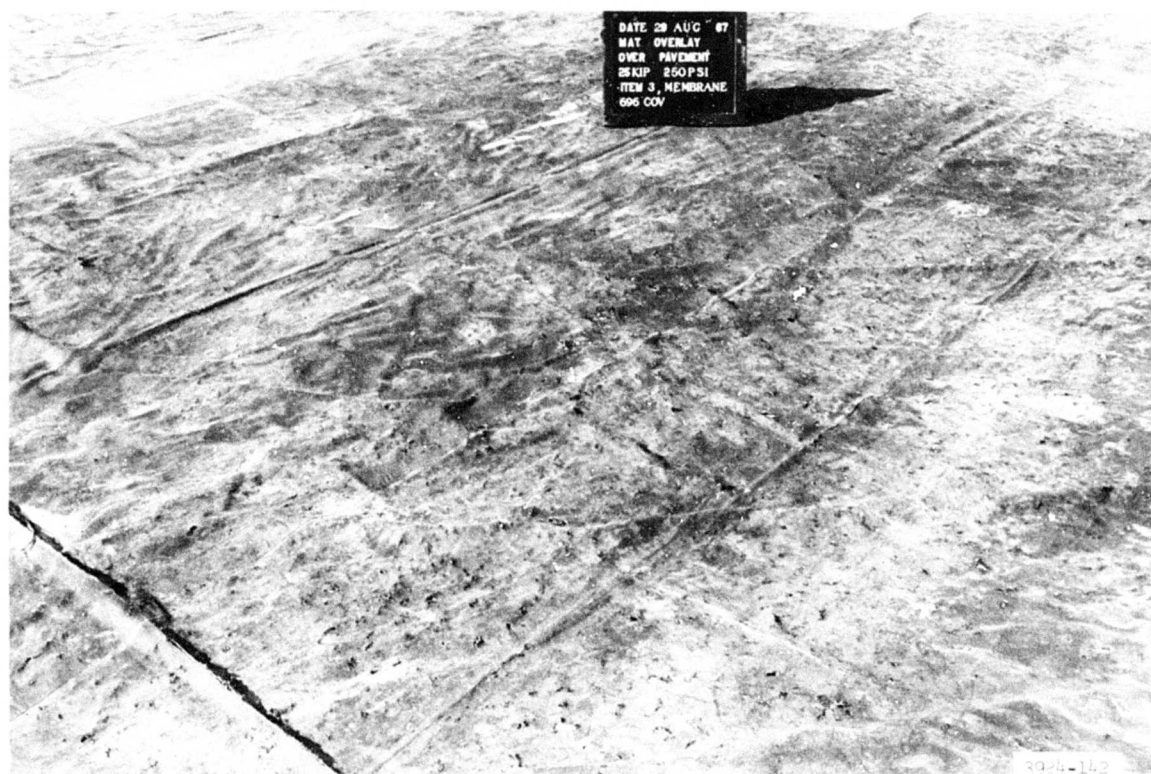
Photograph 44. Numerous holes worn in T16 membrane on item 3 during 366 coverages (696 total coverages on section)

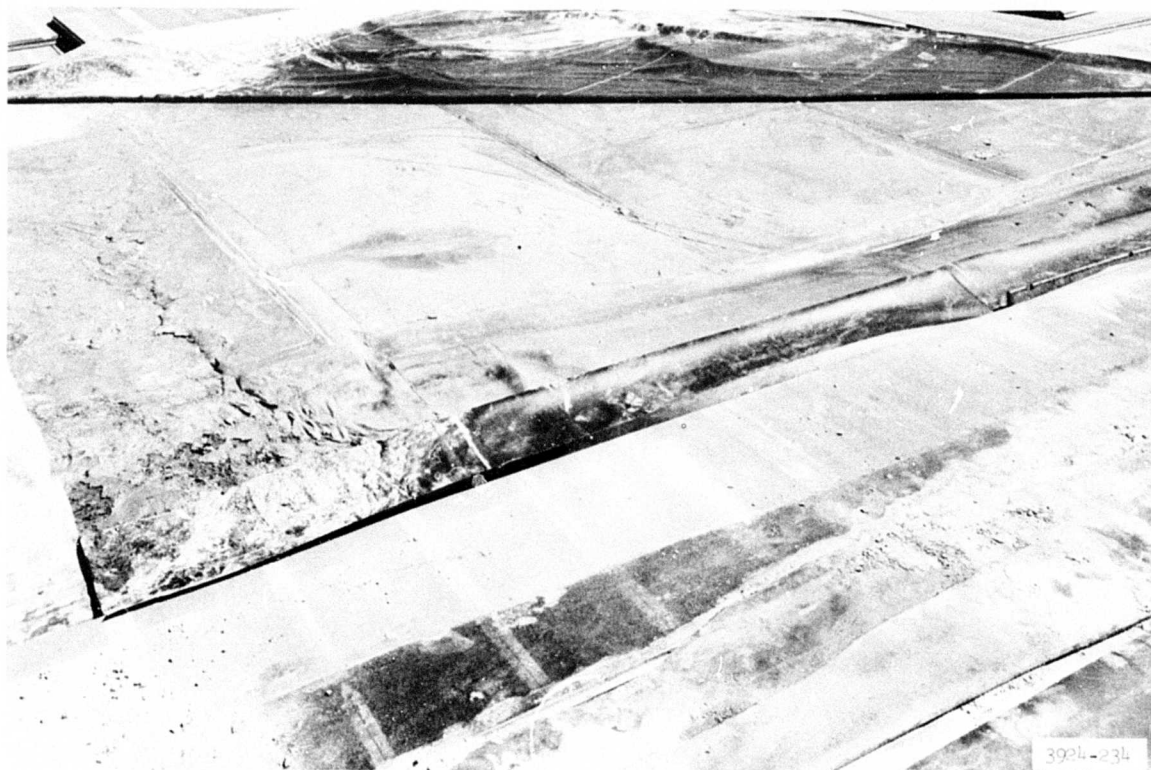
Photograph 51. Condition of soil under failed panel of XM19  
(1850 coverages)
